# Testing and Evaluation of Bridges

Evaluation of the John Coffee Memorial Bridge demonstrates inspection tools of the future

by Mohammad S. Khan

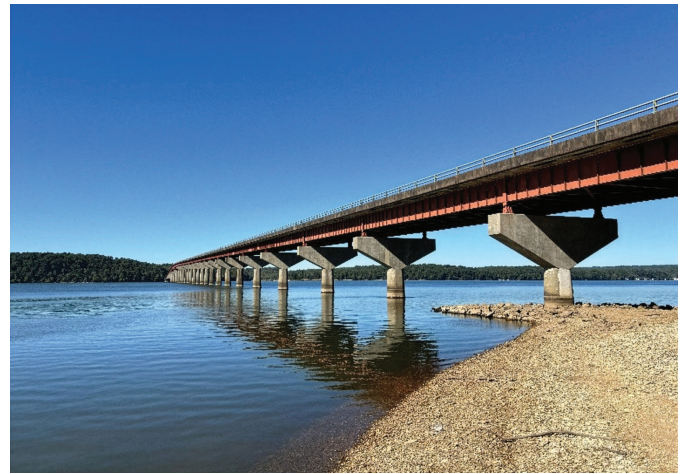
Fig. 1: John Coffee Memorial Bridge

**B**uilt in 1964, the John Coffee Memorial Bridge (Fig. 1) is a nearly 1 mile (1.6 km) long bridge that carries Natchez Trace Parkway over the Tennessee River. The two-lane, 38-span, plate-girder bridge with concrete deck provides a direct route for travelers from Tennessee to Mississippi. While the bridge has exhibited deterioration in both the superstructure and substructure, it has not yet undergone any major rehabilitation. Because of its scale, inspection is challenging. In 2018, for example, a manual visual inspection of the piers required a snooper truck on the deck, traffic control, and a bucket boat on the river waters. A recent evaluation was conducted to select appropriate restoration methods, using robotic tools that enabled nondestructive evaluations (NDEs) without the need for traffic control. This article describes these tools and summarizes the evaluation.

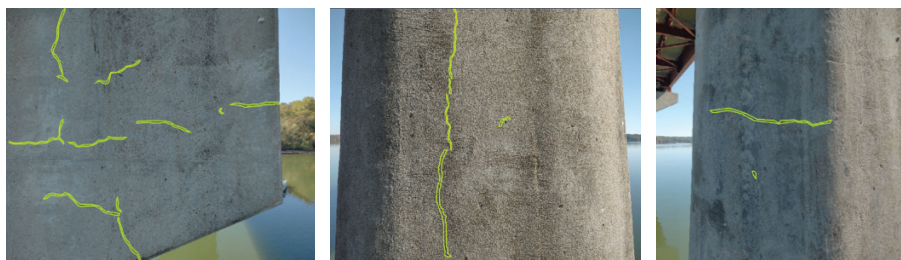
**Fig. 3: Images of Pier 5 were captured using the UAS and subsequently annotated to highlight surface defects**

The UAS survey with HRI and IR cameras generated a large amount of data, with more than 107,000 image files. Given this vast amount of data, it was not practical to manually quantify surface damage in each of the 36 piers and then identify the 10 piers with the most deterioration. A quantitative procedure was developed to rank the piers according to the extent of damage relative to each pier's total surface area. Two types of rankings were developed: one based on identified cracks and the other based on surface defects, including cracks, spalls, and exposed corroded reinforcing steel. In this procedure, images of a pier were examined to ensure that each instance of damage appeared in only one image. Then the damage was marked using image annotation software ROBOFLOW (Fig. 3 and 4). The total number of damage pixels in each image was then calculated, using a program coded in Python. Finally, the damage ratio for each pier was calculated to establish a deterioration ranking. Based on all the surface defects, 10 piers were selected for detailed investigation: Piers 5, 11, 16, 20, 22, 24, 26, 30, 31, and 36.

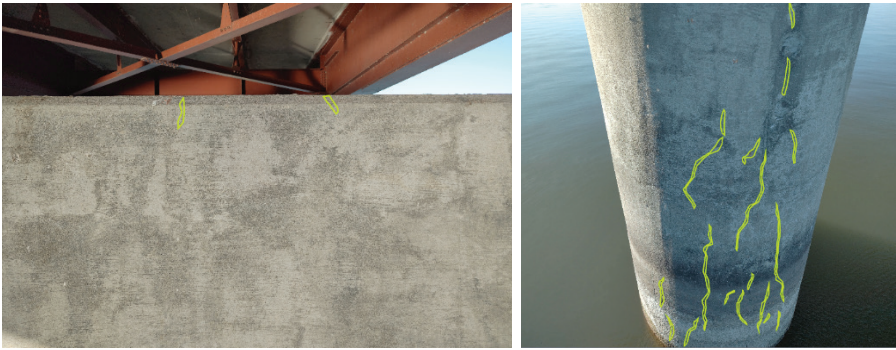
Fig. 4: Enhanced UAS-captured images of Pier 30

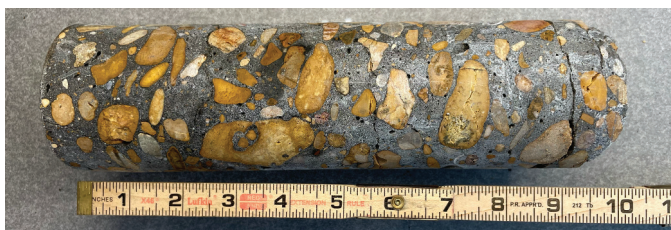
**Fig. 8: Core taken from the southwest face of Pier 30**

The location of the core is indicated as a white circle on the manual GPR deterioration map of the pier (refer to Fig. 6). This pier had a large network of cracks exceeding 0.05 in. (1.27 mm) in width. Crack depths of up to 4.65 in. (118.1 mm) were measured by ultrasonic pulse velocity testing. As shown in Fig. 8, the core was retrieved from one of these crack locations.

This core has multiple cracks, with the surface crack at which the core was taken extending to about 3 in. (76.2 mm) from the surface. There were also two major horizontal cracks at different depths of the core, and it almost broke apart. Visual inspection also showed that the core contained reacted and cracked aggregates. The condition of the core is consistent with the NDE testing results.
